# MEMORANDUM

<b>DATE:</b>	January 18 <sup>th</sup> , 2016
<b>FROM:</b>	Joe Harrington
<b>SUBJECT:</b>	January Weekly Progress Report @ Gold King
<b>TO:</b>	Steven Way

**Project:** Gold King Interim Water Treatment Plant (IWTP)

**Report No.:** 5

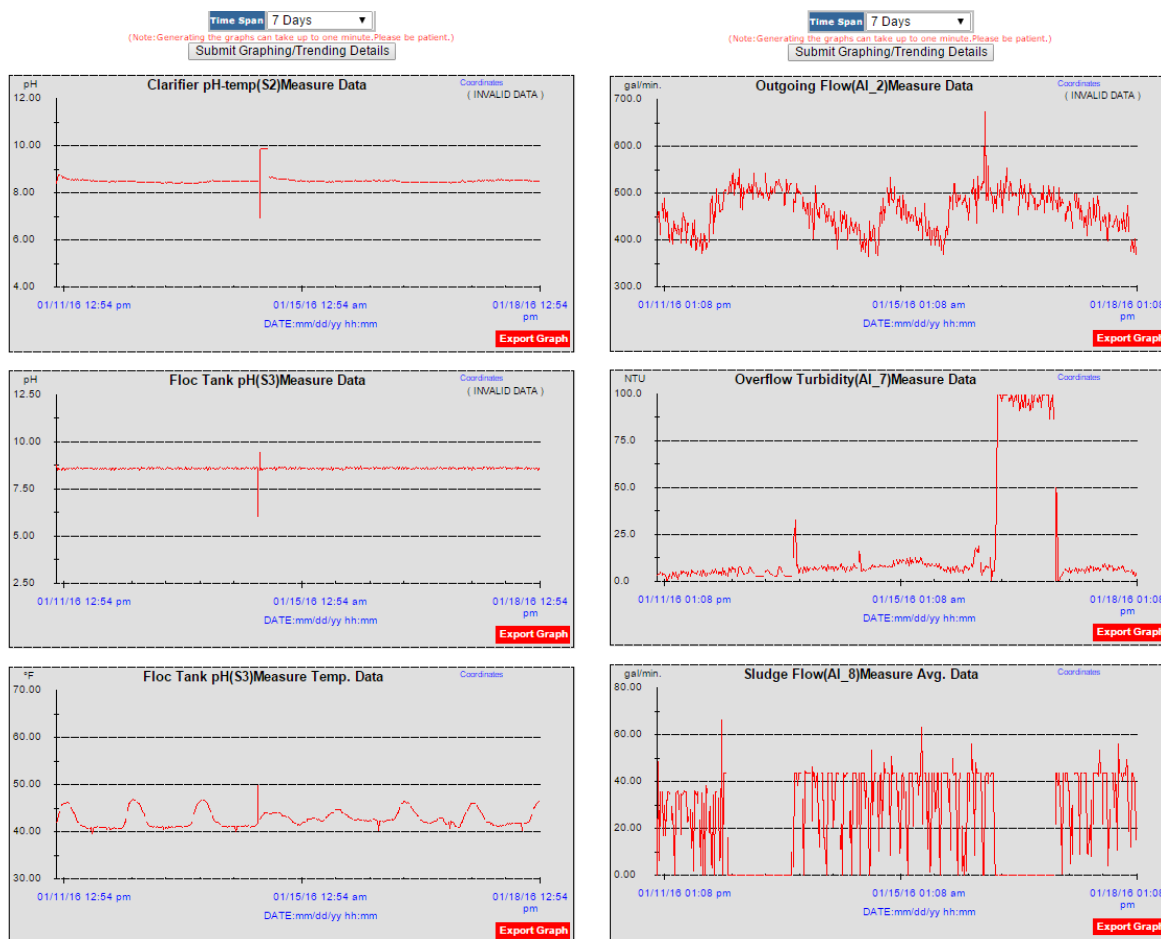
- The following graphs provide trending information collected by datalogging equipment during the previous 7 days. These dataloggers collect control information from the Lime Circuit (left) and Flow Circuit (right) Programmable Logic Controllers (PLCs) at the Gold King IWTP. Over the reporting period (1/11 – 1/18/16 inclusive) Alexco treated 4.96 million gallons at an average of 496 gpm, resulting in 36 gpm to the sludge storage system and 460 gpm to the discharge line.

- Please note: Each day, the Alexco operators check the pH at both the floc tank and clarifier discharge. During this time, the probe is placed in vinegar (acid), and three pH buffers – 4, 7, and 10. While the probe is in the buffer, the datalogger may capture one of those points for tracking purposes, which explains the frequent periodic (daily) pH spikes seen on the graph.

- The flow meter that measures the discharge sludge flow rate from the clarifier became clogged and required cleaning. During this time, no flow was recorded to the sludge bags. It was taken out of service on 1/13/2016, cleaned, and returned to service.

- The airline from the Ingersoll-Rand air compressors froze at 11:00am on Saturday, 1/16/2016. During this time, the air release valve at the bottom of the clarifier was inoperable, resulting in high turbidity water (see spike in NTUs) at the discharge from the clarifier. The airline was replaced, heat-traced, and insulated at 9:00am Sunday, 1/17/2016 and the system returned to normal operation. The compressed air is now being dehydrated through an air dryer and the line is insulated and heat-traced, preventing this issue from re-occurring.
